JOINT PIPELINE OFFICE

Comprehensive Monitoring Program Reports

Evaluation of Alyeska Pipeline Service Company's:

- **Operation of the Trans-Alaska Pipeline
1999/2000**
- **Trans-Alaska Pipeline Construction Program
1999/2000**
- **Trans-Alaska Pipeline Maintenance Program
1999/2000**

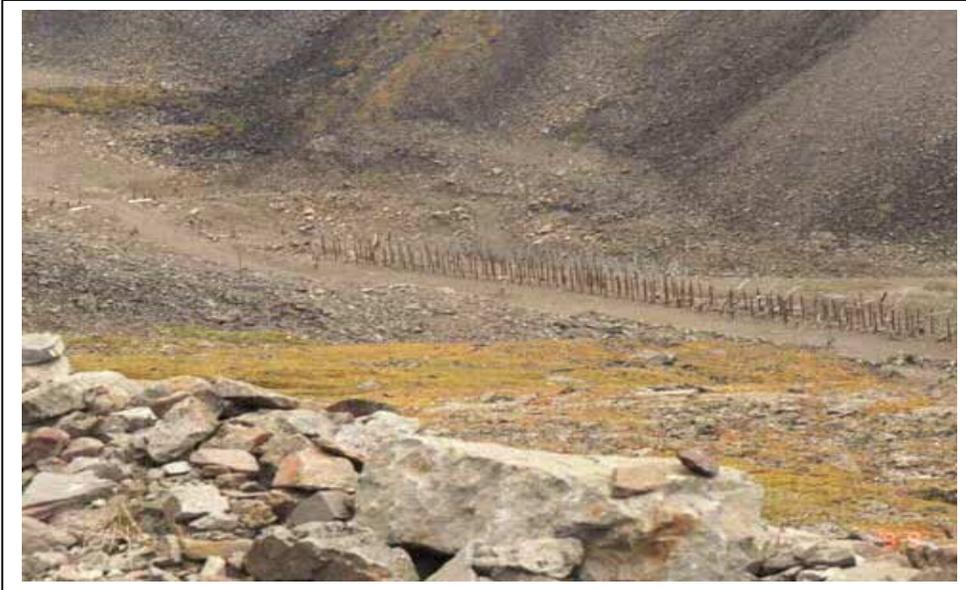
Figure 2: Forest of Heat Pipes to Keep Ground Frozen Near Atigun Pass

1999 Status: In parts of Atigun Pass the pipeline is buried in bedrock laced with ice. In order to keep the ground frozen, freestanding heat pipes were installed in conjunction with the insulated boxes. It was reported in the 1999 Operation CMP that the heat pipes were no longer functioning at pipeline milepost 167.2. In addition, installation of a thermistor string was needed to determine the effectiveness of the existing heat pipes.

2000 Status: JPO conducted surveillance which found that thermistor strings were installed and heat pipes damaged by avalanches were replaced in September 1999.^{26 27}

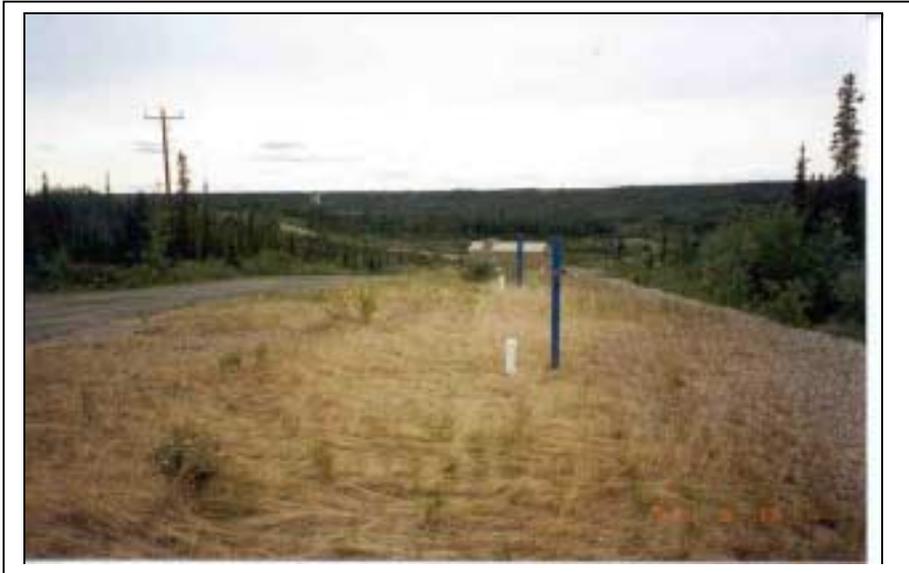
Figure 3: MLR-2, Pipeline Buried with Thermistor String (white) and Monitoring Rods (blue), Refrigeration Plant Building in Foreground

1999 Status: The Main Line Refrigeration Site No 2 (MLR-2) is a 2-mile long buried section of pipeline near the Gulkana River north of Glennallen, Alaska. This area of the pipeline system requires mechanical refrigeration to ensure the soils remain frozen to prevent pipeline settlement. Because of lack of adequate refrigeration, some of the soils below the pipe at MLR-2 thawed, resulting in settlement and curvature of the pipeline. Analysis by Alyeska and review by JPO indicated that the pipe curvature at the Mainline Refrigeration Site No. 2 (MLR-2) is not a pipeline integrity concern provided: 1) the curvature remains constant or decreases, 2) oil temperature does not significantly increase, and 3) pipe wall wrinkling does not occur. JPO requested that Alyeska monitor the pipe monthly until the new permanent refrigeration plants were on line, verify that no wrinkles formed in the pipe, and submit a design basis waiver to address the conditions at MLR-2.

On February 10, 2000, the USDOT/OPS issued a Notice of Probable Violation (NOPV) relating to a 49 CFR 195.401(b) non-compliance. OPS alleges that Alyeska was aware as early as 1992 that the underground insulation at the MLR-2 site was surrounded by water and that no cathodic protection was provided. Therefore, Alyeska operated a section of TAPS at a level of safety lower than that required by regulation and did not correct it within a reasonable amount of time. Alyeska disputes the finding and has requested a hearing.³⁰

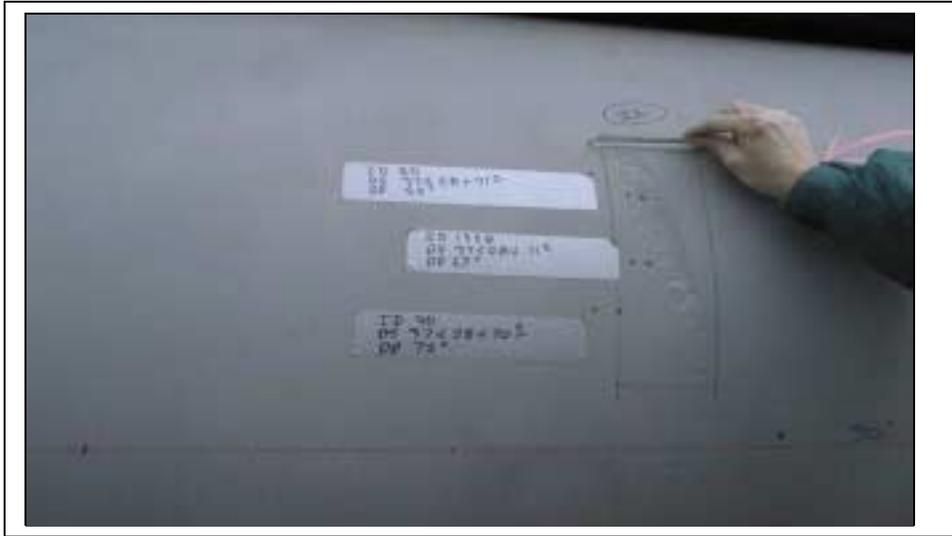
Figure 4: Milepost 710 Gouge

2000 Status: On May 19, 2000 during a scheduled underground corrosion investigation at MP 710 on TAPS, Alyeska discovered mechanical damage to the pipeline. The damage included gouges to the outside of the pipeline in 5 areas, which appear to have been caused by mechanical equipment during construction. The deepest gouge was 80% of the pipe wall thickness. Repairs have been completed, which included smoothing and grinding the sharp edges of the gouges, installing steel sleeves, recoating, and derating the maximum operating pressure from 901 to 838 psi. Presently, the pipeline is operating at 620 psi at a throughput of 1.1 million bbls/day. Further, because the corrosion pig underestimated the extent of the pipe damage, JPO/OPS is evaluating the magnetic and transverse flux pigs to determine their ability to better define the extent of pipe damage due to gouges and corrosion at girth welds.

USDOT/OPS asserts that Alyeska increased the pressure at MP 710.76 at a time when it had been discovered that the pipeline was in indeterminate condition caused from a severe

mechanical damage to the pipe wall. OPS is pursuing a Notice of Probable Violation (NOPV) relating to a 49 CFR 195.422 (pipeline repair) non-compliance.³¹

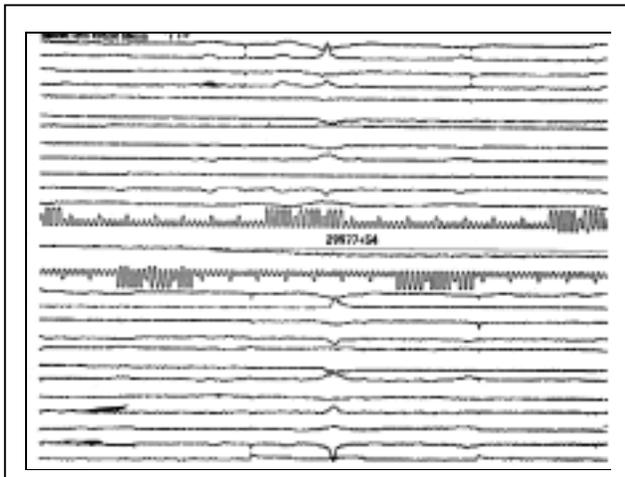
2000 Status: JPO compared the deformation pig data prior to the August 5, 1998 incident to deformation data measured in October 1998 after the event and verified Alyeska’s conclusion that there was no observable damage. JPO also verified that additional logic changes had been implemented in the pipeline control system to reduce the likelihood of this type of event in the future.

Figure 6: July 1998 VETCO Pig Data Prior to Overpressure Event Showing 1 inch Dent at 6:00 Position

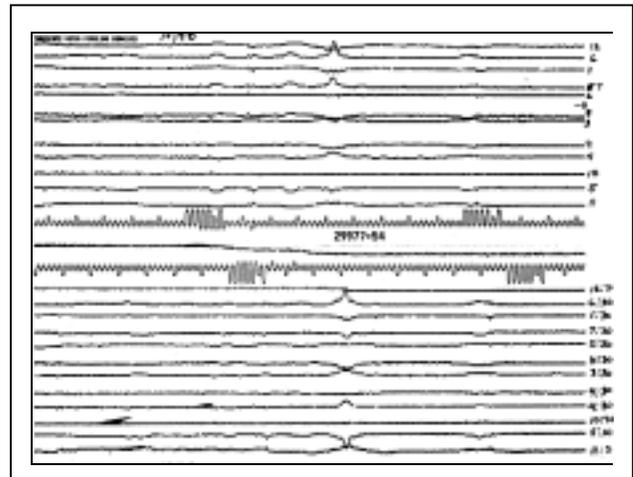
Figure 7: October 1998 VETCO Pig Data After Overpressure Event Showing no Change

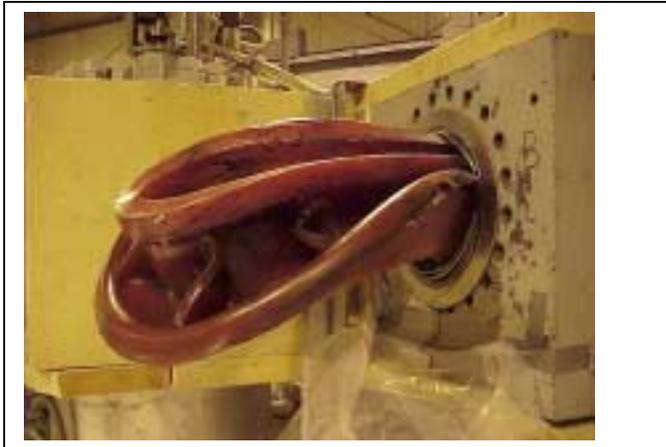
Figure 8: Backpressure System Valve B, 18" Oil Entrance Filled with 48" Pig Cups

2000 Status: On January 30, 2000, the backpressure system at the Valdez Marine Terminal was damaged primarily as the result of failing to follow and use procedures for the capture of a scraper pig in the pig trap. In addition, the management of change process was not followed to prepare a procedure for receipt of two pigs in the pig trap. The failure to follow procedure and poor change management represents an incident where safe and workmanlike pipeline operations were not followed as required by Grant and Lease Stipulation 1.21. The damage to the backpressure system has been repaired and is now in operation. Without the backpressure system in operation and with oil flow rate below 1.4 million/barrel day, vibrations due to oil vapor bubble collapse are induced into the TAPS pipeline just below Thompson Pass. JPO directed Alyeska to report the effect of the vibrations on pipeline integrity. The report's calculations show that the worst location, if the backpressure system remained offline, that in 1.5 years the pipe would reach an indeterminate condition for continued operations. There would be a 2% chance of the initiation of a crack in the pipe. The length of time to propagate this crack through the pipe wall is unknown. If the backpressure system is kept online and with 12 shutdowns/year it would take 24 years to reach a cumulative design fatigue damage of 100%.³⁹

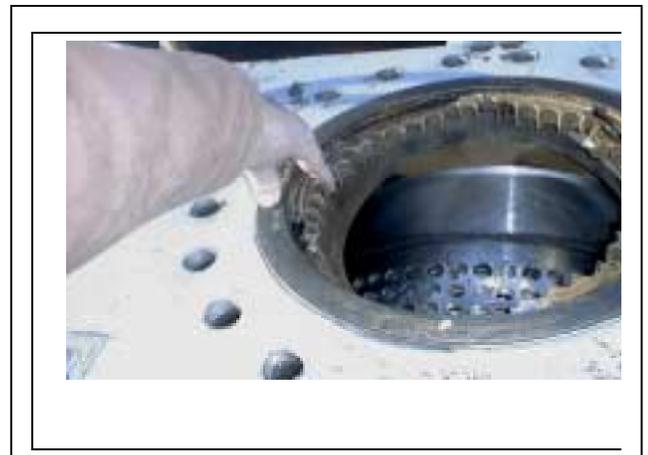
Figure 9: Steel Screen Destroyed by Pig

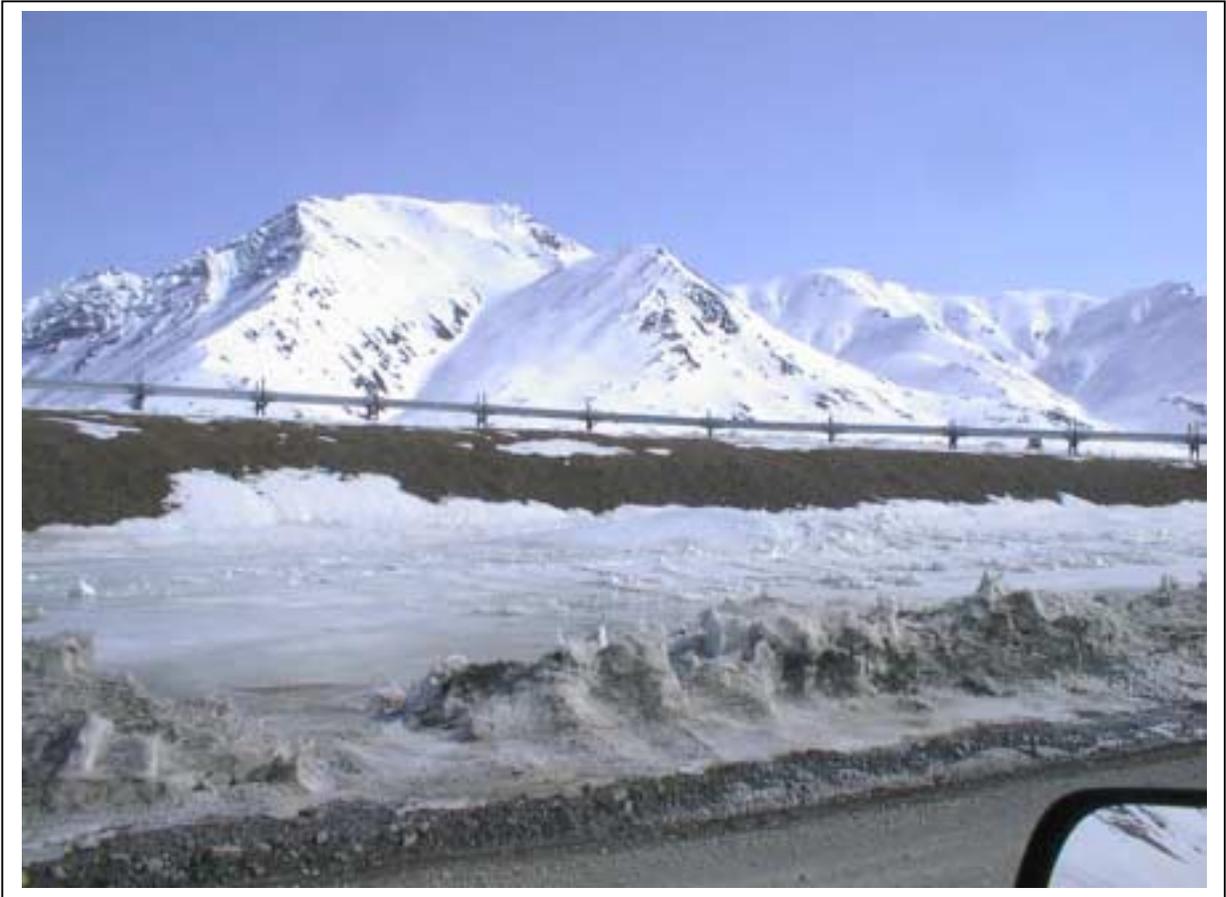
Figure 13: View of Pipeline near Milepost 170 from Road after Event

2000 Status: A design change of August 22, 1999 did not adequately take into account the hydraulic conditions resulting from timing of the opening of RGV-31, given a slack line condition below RGV-31. A pressure pulse was generated. The forces generated tripped seven pipeline anchors, sheared steel bolts on the anchor frames and moved the pipeline south up to 23 inches. Alyeska surveillance failed to find the damage until over a month after the incident is believed to have taken place. Subsequently, Alyeska has changed the timing at RGV-31, conducted soil gas monitoring and found no anomalous soil gas readings at the other below ground valves and modified their surveillance process by painting orange marker lines on the pipe anchor supports to make movement more evident.

- **Follow up:**
- Alyeska changed the opening sequence at RGV-31 to allow only 20% initial opening for ten minutes. Surge calculations indicate that this will prevent similar events in the future.⁵⁴
- Alyeska conducted soil gas monitoring and found no anomalous soil gas readings⁵⁵ and modified its surveillance process by painting orange marker lines on the pipe anchor supports to make movement more evident.⁵⁶
- Alyeska has completed the repair of the pipe supports at MP 170.
- JPO awaits the Curvature/Deformation Pig data to verify the condition of the below ground pipe downstream from RGV-31. The pig was run August 2000. The data is expected to be available by early in the year 2001.

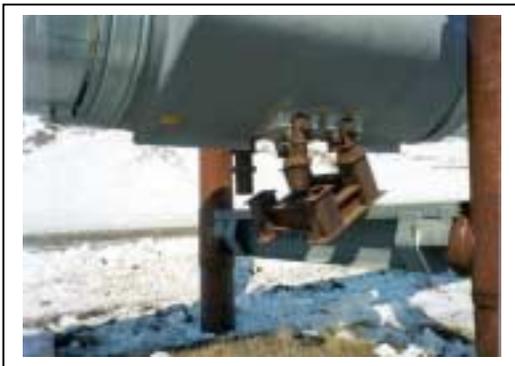
Figure 14: Pipeline Shoe Nearly Off Support

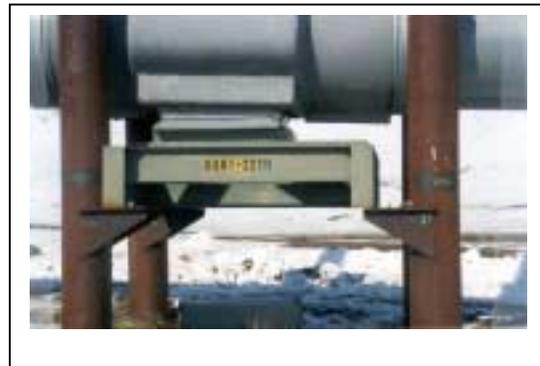
Figure 15: Anchor Platform Moved Against VSM

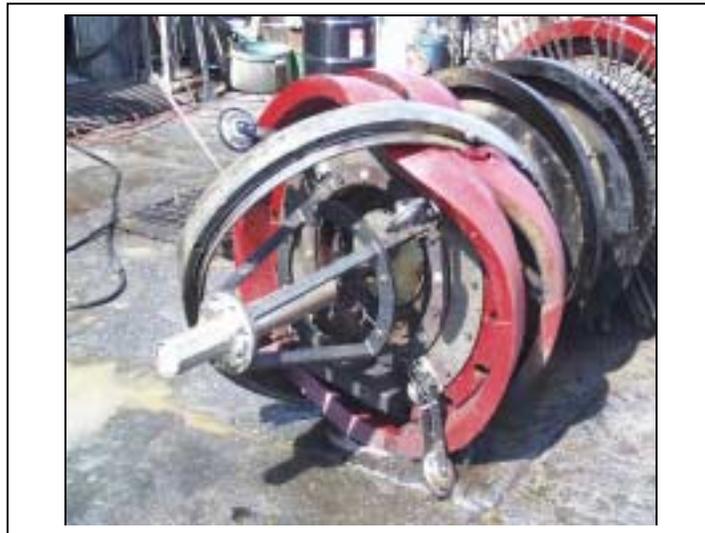
Figure 18: Check Valve 74 Seat Ring on BJ Curvature Pig

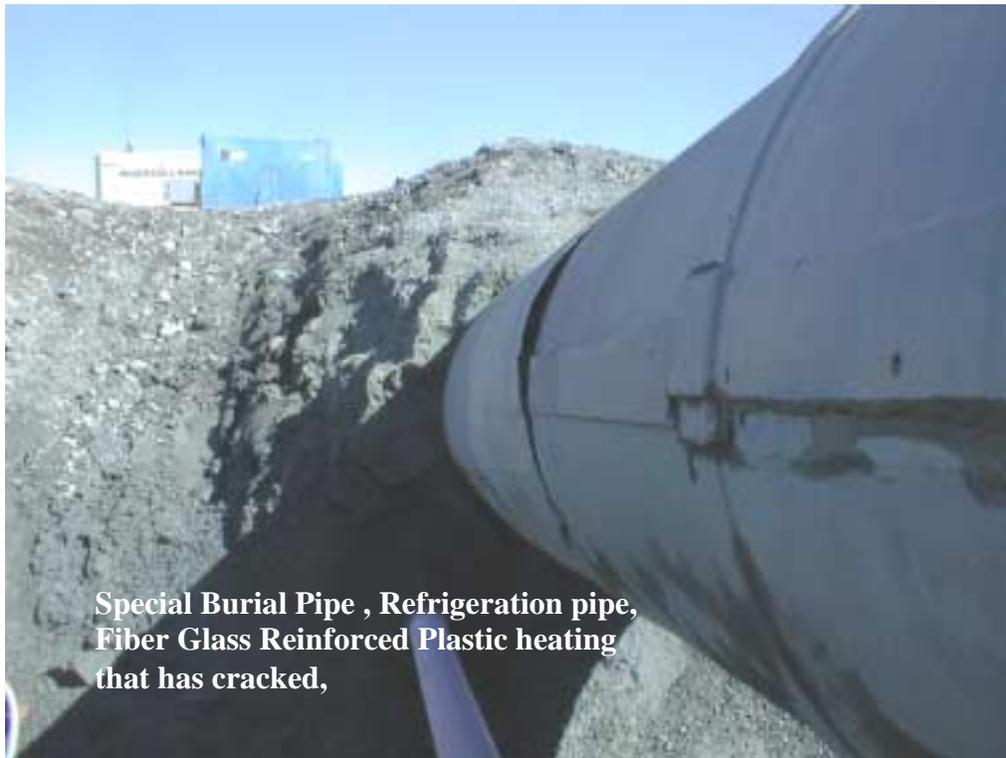
**Special Burial Pipe , Refrigeration pipe,
Fiber Glass Reinforced Plastic heating
that has cracked,**
