# **JOINT PIPELINE OFFICE**

## **Comprehensive Monitoring Program Report**

### **Evaluation of Alyeska Pipeline Service Company's TAPS Employee Safety Program**

**April 1998**

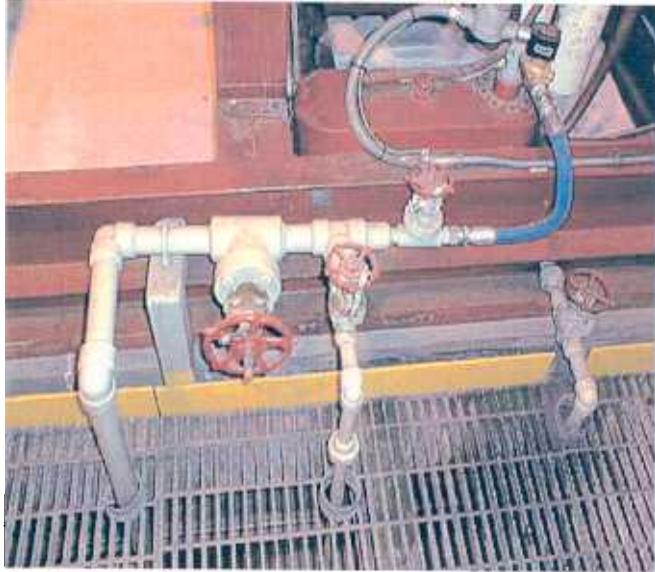
The results of JPO's surveillance and subsequent assessment process led JPO to conclude that Alyeska has developed and implemented their Car Seal Program and the audit action items are not recurring. For example, the car seal logs that are used in accordance with SA-38 to track the status of car sealed valves at all times is an extra safety measure. Alyeska audits the car seal logs on a periodic basis to make sure the recorded information reflects the actual car seal and valve positions. Although JPO did not have findings, there was one observation that two valves at a pump station could be moved without breaking the car seal, which defeats the purpose of the car seal. The observation was reported to Alyeska and has been resolved.

**Figure 1.** The thin metal tags secured to the valves are car seals.

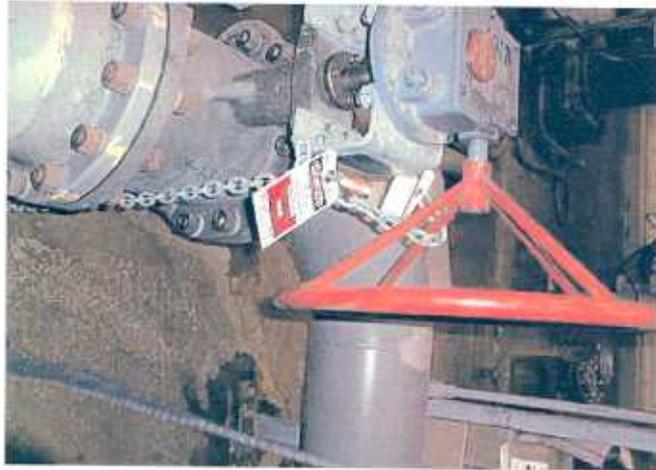
**Figure 3.** A valve locked and tagged.

1. At the Valdez Marine Terminal, technicians locked out equipment for maintenance without using a danger tag or entering the lock out status in the Clearance Order Log, the method for tracking systems that have been locked out. Personnel felt it wasn't necessary to tag and document short jobs that could be completed in one shift. However, SA-38 requires all locks to be tagged and entered in the Clearance Order Log. JPO notified Alyeska and they resolved the problem.

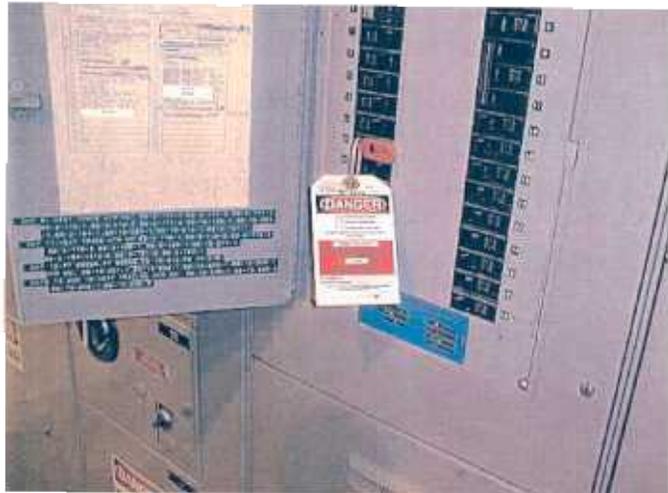
**Figure 2.** An electrical circuit breaker locked and tagged.

2. SA-38 also requires periodic reviews of the Clearance Order Logs, to track which systems have been locked out and verify whether these systems should remain locked out. JPO found that one pump station was overdue for their annual review of Clearance Order Logs. When JPO brought this to the attention of pump station personnel, the log review was completed.

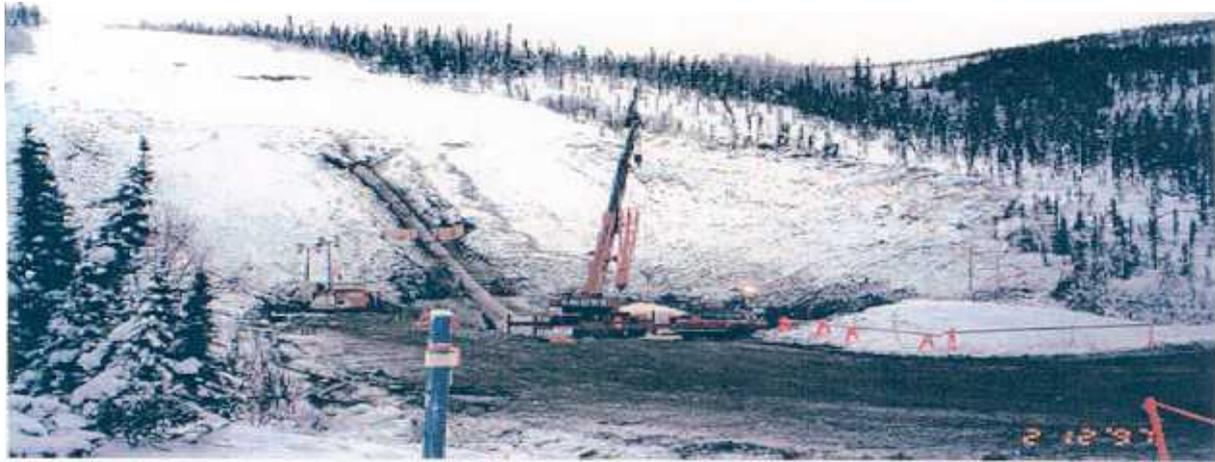
Figure 4. Early stages of Wilber Creek pipeline excavation. Notice the slope of the hill.

The Wilber Creek corrosion repair was completed early in 1997. Excavation at this site was complicated by steep terrain and deep burial of the pipeline. After assessing the technical ~~identified and resolved~~ complexity of the Wilber Creek excavation, JPO obtained the expertise of an outside excavation consultant, Robert Carrier, from the Alaska Department of Labor, Division of Occupational Safety and Health to evaluate the safeguards and excavation activities at this site.

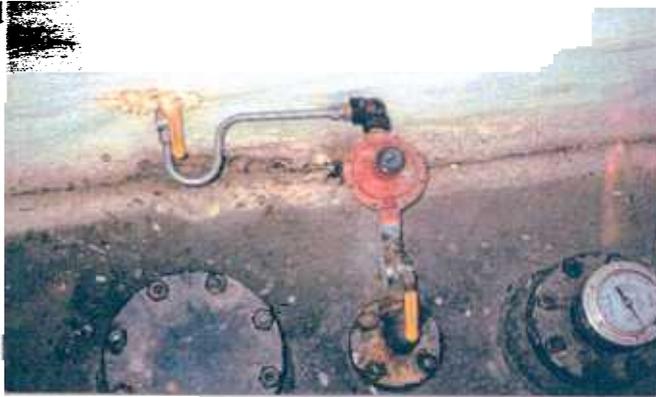
- 2 Each Remote Gate Valve has two vaults that contain and conceal one propane tank, which fuels the power generator at the RGV site. In the Pump Station 5 area, the propane tank vaults filled with water and rusted the fuel pressure regulators, causing the propane to leak. The problem was solved by relocating the regulator to the top of the tank vault above the water level. Alyeska then inspected other RGV propane tanks linewide and found that this problem was confined to the Pump Station 5 area. JPO sampled 12 other tanks along the pipeline and agreed with Alyeska's conclusion that the problem was limited to the Pump Station 5 area.

**Figure 5.** A propane regulator at a Remote Gate Valve. Notice the corrosion.
