## **Comprehensive Monitoring Program Report**

### **A Look at Alyeska Pipeline Service Company's Operation of the Trans-Alaska Pipeline System 1999/2000**

February 2001

# **Joint Pipeline Office**

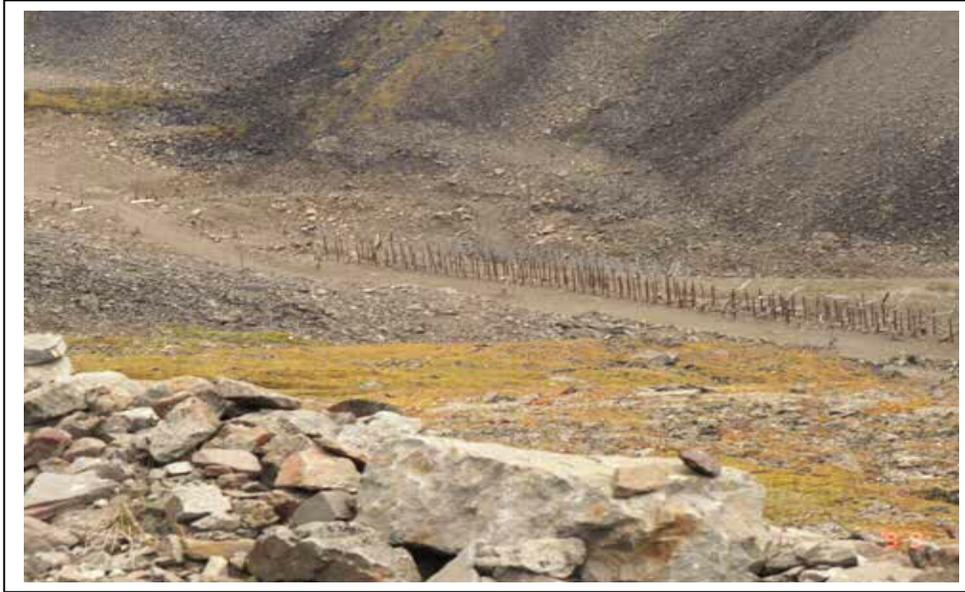
**Figure 2: Forest of Heat Pipes to Keep Ground Frozen Near Atigun Pass**

**1999 Status:** In parts of Atigun Pass the pipeline is buried in bedrock laced with ice. In order to keep the ground frozen, freestanding heat pipes were installed in conjunction with the insulated boxes. It was reported in the 1999 Operation CMP that the heat pipes were no longer functioning at pipeline milepost 167.2. In addition, installation of a thermistor string was needed to determine the effectiveness of the existing heat pipes.

**2000 Status:** JPO conducted surveillance which found that thermistor strings were installed and heat pipes damaged by avalanches were replaced in September 1999.<sup>26 27</sup>

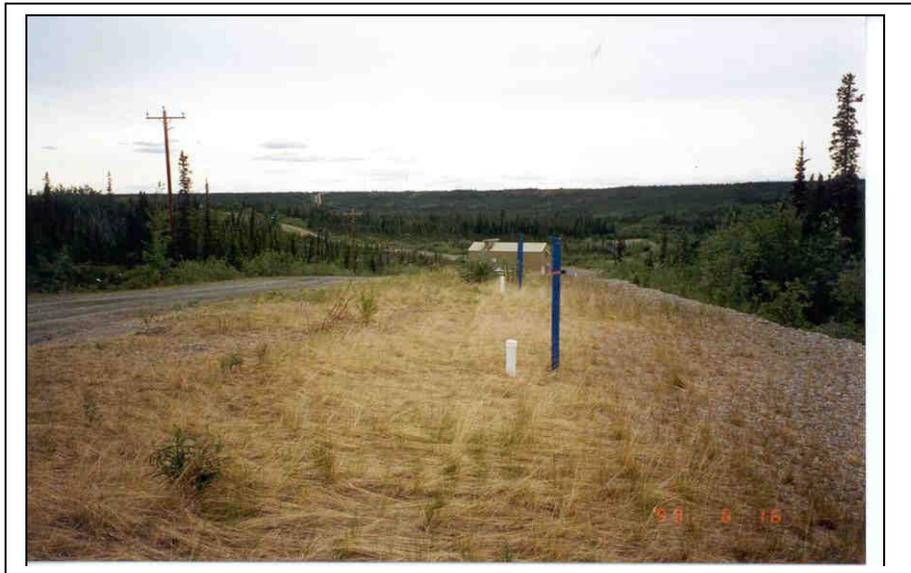
**Figure 3: MLR-2, Pipeline Buried with Thermistor String (white) and Monitoring Rods (blue), Refrigeration Plant Building in Foreground**

**1999 Status:** The Main Line Refrigeration Site No 2 (MLR-2) is a 2-mile long buried section of pipeline near the Gulkana River north of Glennallen, Alaska. This area of the pipeline system requires mechanical refrigeration to ensure the soils remain frozen to prevent pipeline settlement. Because of lack of adequate refrigeration, some of the soils below the pipe at MLR-2 thawed, resulting in settlement and curvature of the pipeline. Analysis by Alyeska and review by JPO indicated that the pipe curvature at the Mainline Refrigeration Site No. 2 (MLR-2) is not a pipeline integrity concern provided: 1) the curvature remains constant or decreases, 2) oil temperature does not significantly increase, and 3) pipe wall wrinkling does not occur. JPO requested that Alyeska monitor the pipe monthly until the new permanent refrigeration plants were on line, verify that no wrinkles formed in the pipe, and submit a design basis waiver to address the conditions at MLR-2.

On February 10, 2000, the USDOT/OPS issued a Notice of Probable Violation (NOPV) relating to a 49 CFR 195.401(b) non-compliance. OPS alleges that Alyeska was aware as early as 1992 that the underground insulation at the MLR-2 site was surrounded by water and that no cathodic protection was provided. Therefore, Alyeska operated a section of TAPS at a level of safety lower than that required by regulation and did not correct it within a reasonable amount of time. Alyeska disputes the finding and has requested a hearing.<sup>30</sup>

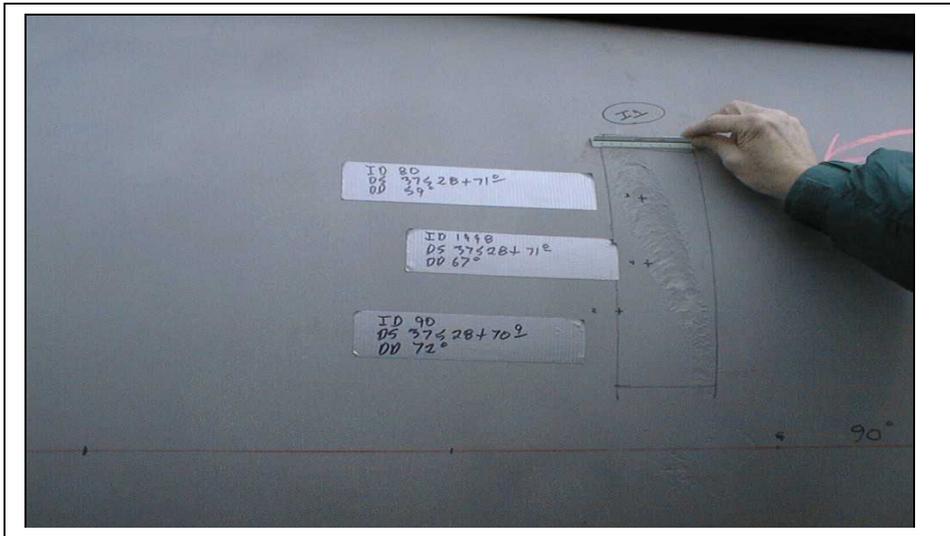
Figure 4: Milepost 710 Gouge

**2000 Status:** On May 19, 2000 during a scheduled underground corrosion investigation at MP 710 on TAPS, Alyeska discovered mechanical damage to the pipeline. The damage included gouges to the outside of the pipeline in 5 areas, which appear to have been caused by mechanical equipment during construction. The deepest gouge was 80% of the pipe wall thickness. Repairs have been completed, which included smoothing and grinding the sharp edges of the gouges, installing steel sleeves, recoating, and derating the maximum operating pressure from 901 to 838 psi. Presently, the pipeline is operating at 620 psi at a throughput of 1.1 million bbls/day. Further, because the corrosion pig underestimated the extent of the pipe damage, JPO/OPS is evaluating the magnetic and transverse flux pigs to determine their ability to better define the extent of pipe damage due to gouges and corrosion at girth welds.

USDOT/OPS asserts that Alyeska increased the pressure at MP 710.76 at a time when it had been discovered that the pipeline was in indeterminate condition caused from a severe

mechanical damage to the pipe wall. OPS is pursuing a Notice of Probable Violation (NOPV) relating to a 49 CFR 195.422 (pipeline repair) non-compliance.<sup>31</sup>

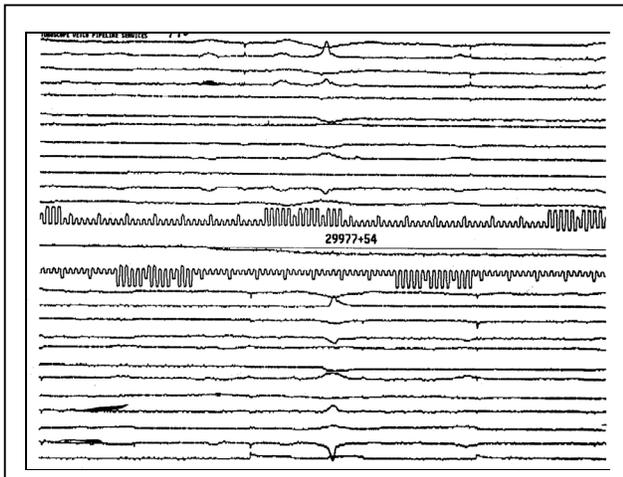
**Figure 6: July 1998 VETCO Pig Data Prior to Overpressure Event Showing 1 inch Dent at 6:00 Position**

On August 5, 1998, a significant overpressure of the Trans-Alaska Pipeline System occurred. Hydraulic pressure exceeded 110% maximum allowable operating pressure (MAOP) in the 32-mile segment between Pump Station 9 and 10. Alyeska completed a hydraulic analysis indicating that the pressure had peaked at 130% MAOP near Pipeline Milepost 568, south of Delta Junction, Alaska. Alyeska investigated the condition of the pipe after the event with the VETCO Deformation Pig. Alyeska found no change in the condition of the pipe after comparing the deformation data to previous Deformation Pig investigations.<sup>36</sup> JPO verified the analysis by comparing deformation data before and after overpressure event.<sup>37</sup> No change in pipe condition was found.

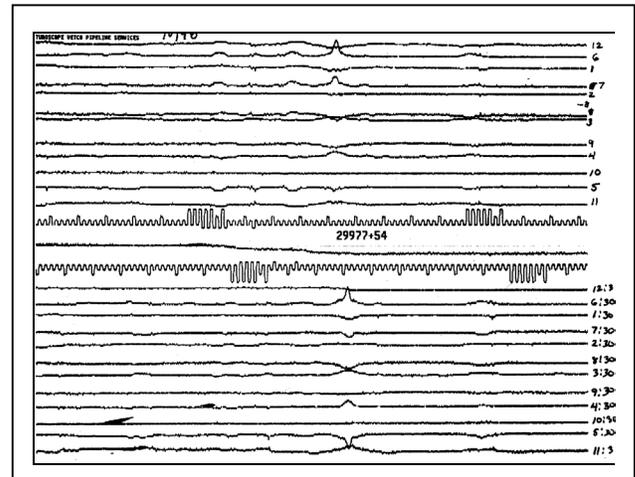
**2000 Status:** JPO compared the deformation pig data prior to the August 5, 1998 incident to deformation data measured in October 1998 after the event and verified Alyeska's conclusion that there was no observable damage. JPO also verified that additional logic changes had been implemented in the pipeline control system to reduce the likelihood of this type of event in the future.

**Figure 7: October 1998 VETCO Pig Data After Overpressure Event Showing no Change**

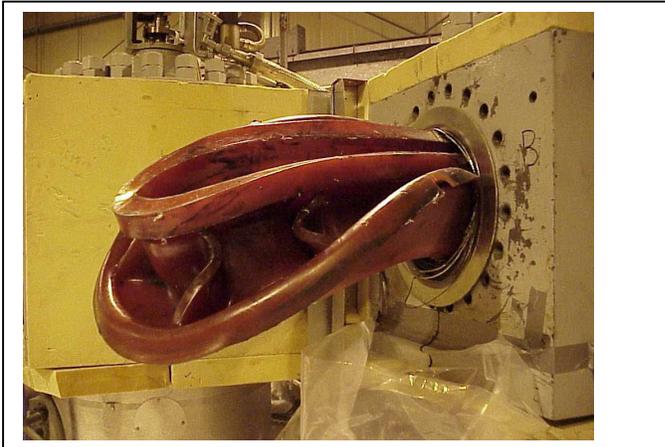
**Figure 8: Backpressure System Valve B, 18" Oil Entrance Filled with 48" Pig Cups**

**2000 Status:** On January 30, 2000, the backpressure system at the Valdez Marine Terminal was damaged primarily as the result of failing to follow and use procedures for the capture of a scraper pig in the pig trap. In addition, the management of change process was not followed to prepare a procedure for receipt of two pigs in the pig trap. The failure to follow procedure and poor change management represents an incident where safe and workmanlike pipeline operations were not followed as required by Grant and Lease Stipulation 1.21. The damage to the backpressure system has been repaired and is now in operation. Without the backpressure system in operation and with oil flow rate below 1.4 million/barrel day, vibrations due to oil vapor bubble collapse are induced into the TAPS pipeline just below Thompson Pass. JPO directed Alyeska to report the effect of the vibrations on pipeline integrity. The report's calculations show that the worst location, if the backpressure system remained offline, that in 1.5 years the pipe would reach an indeterminate condition for continued operations. There would be a 2% chance of the initiation of a crack in the pipe. The length of time to propagate this crack through the pipe wall is unknown. If the backpressure system is kept online and with 12 shutdowns/year it would take 24 years to reach a cumulative design fatigue damage of 100%.<sup>39</sup>

**Details:** On January 30, 2000, the backpressure system at the Valdez Marine Terminal was damaged primarily as the result of failing to follow and use procedures during the capture of a scraper pig.<sup>40</sup> JPO directed Alyeska to provide: 1) a plan and schedule for the repair of the backpressure system; 2) a briefing on the causal factor analysis of the damage to the backpressure system; 3) an estimate of how long the backpressure system could remain off line without a danger to the integrity of the pipeline.<sup>41</sup>

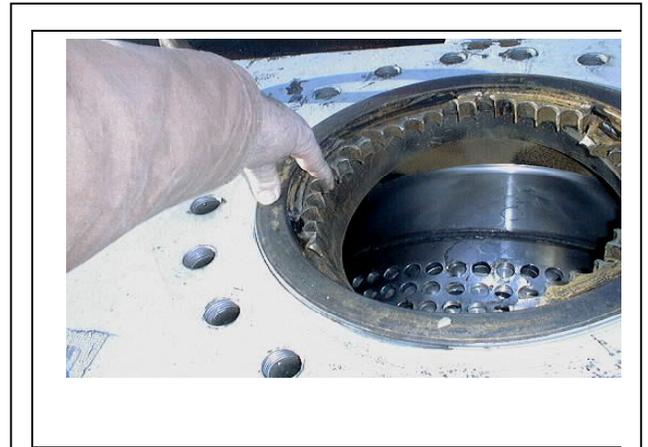
**Figure 9: Steel Screen Destroyed by Pig**

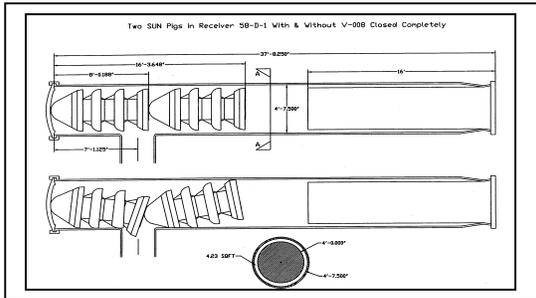
**Figure 11: Effect of Two Pigs in Pig Trap (modified from Alyeska RCA)**

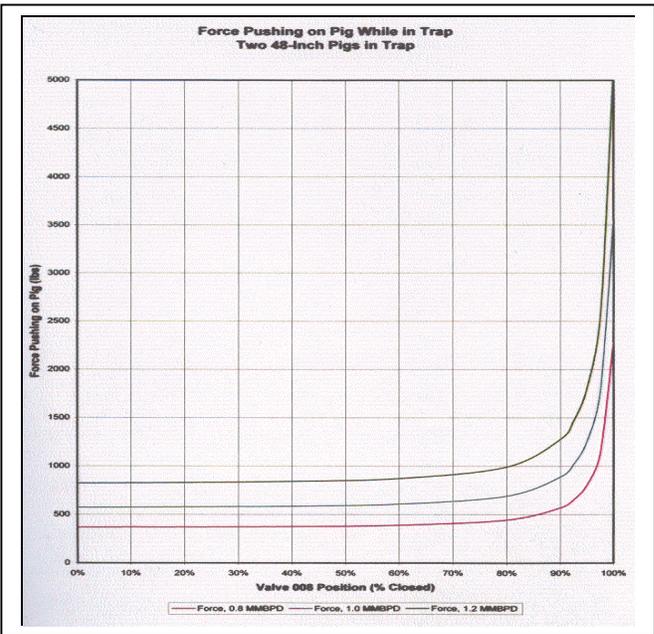
**Figure 12 Effect of Closing Valve 008 (modified from Alyeska RCA)**

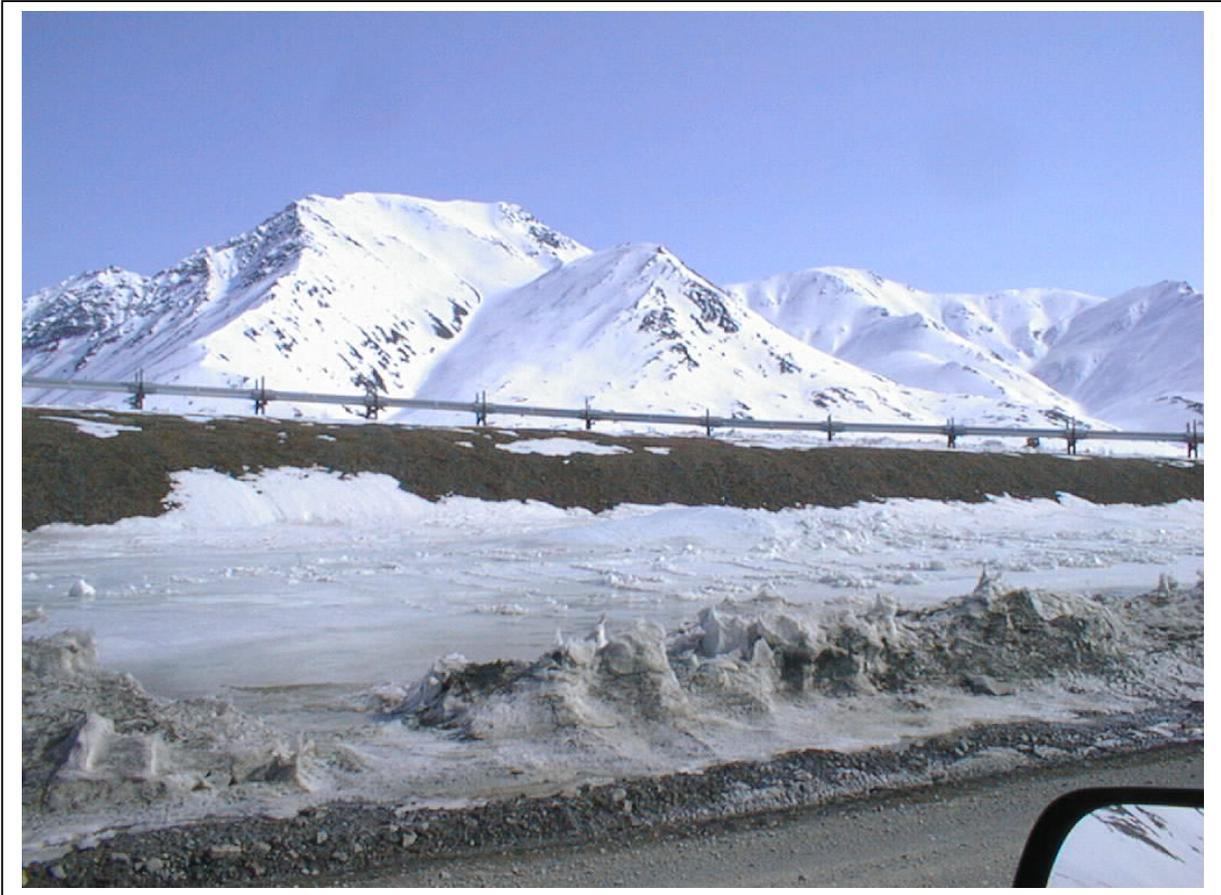
**Figure 13: View of Pipeline near Milepost 170 from Road after Event**

**2000 Status:** A design change of August 22, 1999 did not adequately take into account the hydraulic conditions resulting from timing of the opening of RGV-31, given a slack line condition below RGV-31. A pressure pulse was generated. The forces generated tripped seven pipeline anchors, sheared steel bolts on the anchor frames and moved the pipeline south up to 23 inches. Alyeska surveillance failed to find the damage until over a month after the incident is believed to have taken place. Subsequently, Alyeska has changed the timing at RGV-31, conducted soil gas monitoring and found no anomalous soil gas readings at the other below ground valves and modified their surveillance process by painting orange marker lines on the pipe anchor supports to make movement more evident.

- **Follow up:**
- Alyeska changed the opening sequence at RGV-31 to allow only 20% initial opening for ten minutes. Surge calculations indicate that this will prevent similar events in the future.<sup>54</sup>
- Alyeska conducted soil gas monitoring and found no anomalous soil gas readings<sup>55</sup> and modified its surveillance process by painting orange marker lines on the pipe anchor supports to make movement more evident.<sup>56</sup>
- Alyeska has completed the repair of the pipe supports at MP 170.
- JPO awaits the Curvature/Deformation Pig data to verify the condition of the below ground pipe downstream from RGV-31. The pig was run August 2000. The data is expected to be available by early in the year 2001.

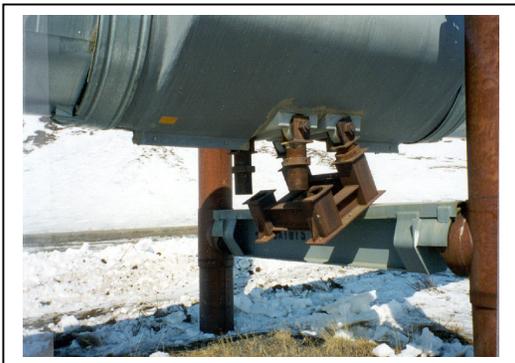
**Figure 14: Pipeline Shoe Nearly Off Support**

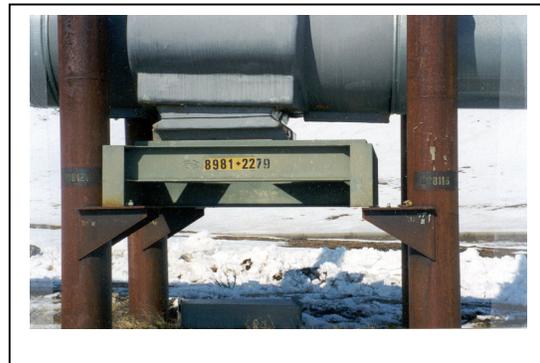
**Figure 15: Anchor Platform Moved Against VSM**

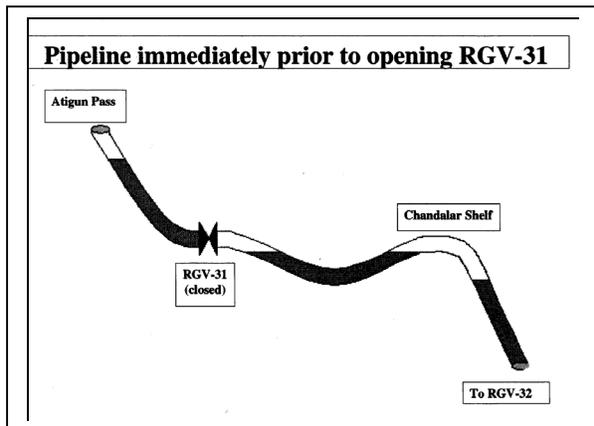
**Figure 16: Oil Position Prior to RGV 31 Opening (modified from Alyeska RCA)**

The Alyeska root cause analysis (Alyeska RCA) found that a pressure pulse was caused by the collapse of a vapor pocket just south of RGV-31 when RGV-31 was reopened after a pipeline shutdown on April 17, 2000.<sup>51</sup> This pressure pulse caused the damage to the pipeline supports. Figure 16 (above) shows the position of the oil in the pipeline prior to the opening of RGV-31. Once RGV-31 was fully open, the oil column above RGV-31 traveled and collided with the column down stream shown in Figure 17. The impact caused a pressure pulse to move downstream and upstream. Most of the upstream section of pipe is aboveground. The above ground pipe is designed to move in a controlled manner and absorb energy using various sacrificial elements such as aluminum honeycomb absorbers at the pipeline anchors. The below ground pipe is restrained by the surrounding soil and does not experience lateral or transverse movement.

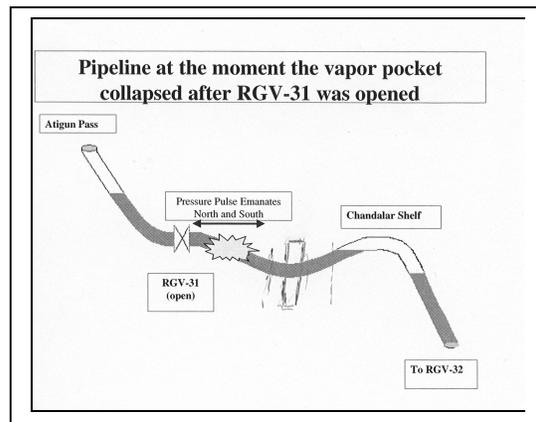
**Figure 17: Collision of Oil Columns (modified from Alyeska RCA)**

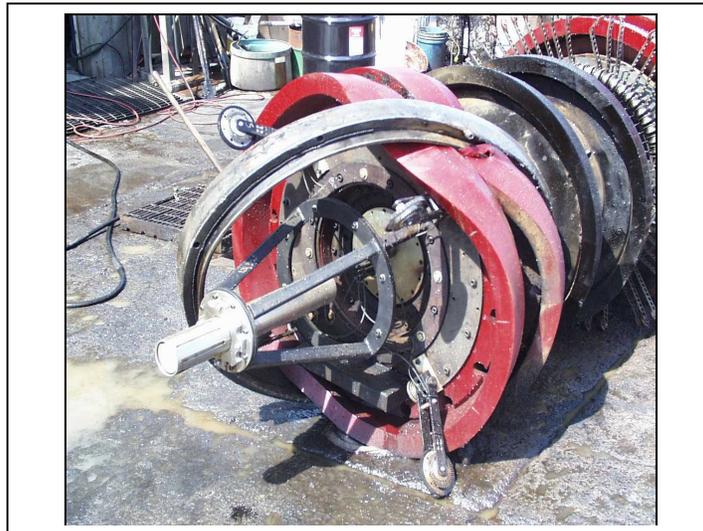
**Figure 18: Check Valve 74 Seat Ring on BJ Curvature Pig**
