JOINT PIPELINE OFFICE

Comprehensive Monitoring Program Reports

Evaluation of Alyeska Pipeline Service Company's:

- **Operation of the Trans-Alaska Pipeline
1999/2000**
- **Trans-Alaska Pipeline Construction Program
1999/2000**
- **Trans-Alaska Pipeline Maintenance Program
1999/2000**

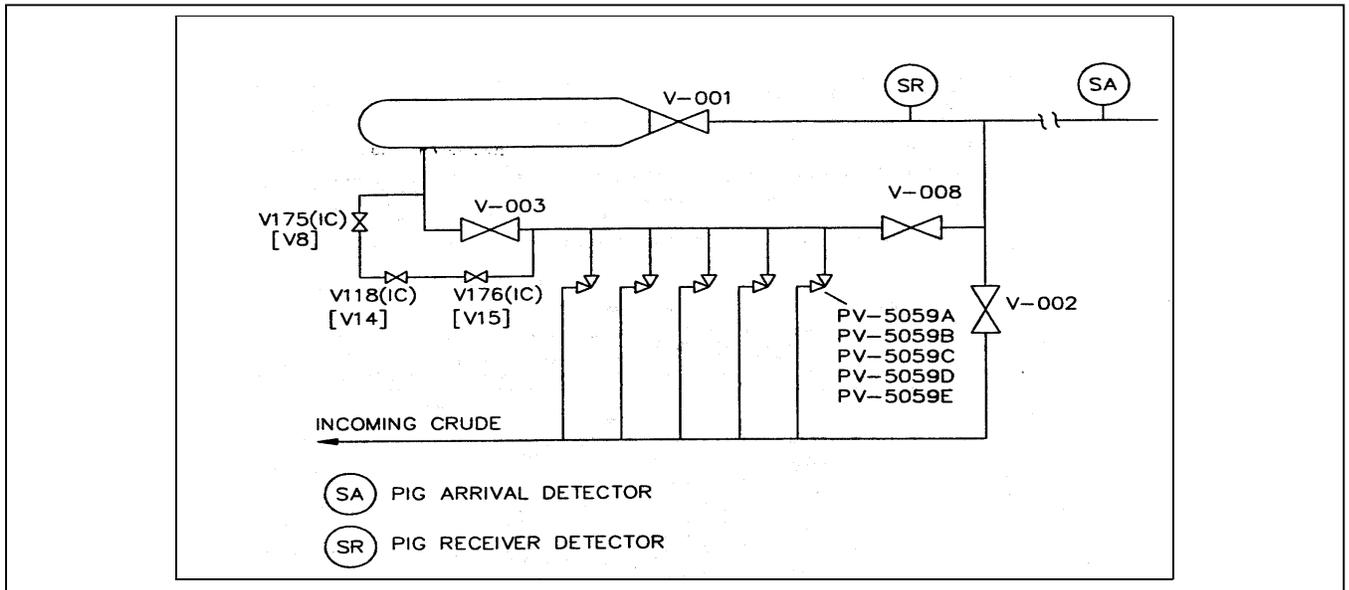
Figure 10: Piping & Valves Connection Pig Trap and Backpressure System

2000 Status: On January 30, 2000, the backpressure system at the Valdez Marine Terminal was damaged primarily as the result of failing to follow and use procedures for the capture of a scraper pig in the pig trap. In addition, the management of change process was not followed to prepare a procedure for receipt of two pigs in the pig trap. The failure to follow procedure and poor change management represents an incident where safe and workmanlike pipeline operations were not followed as required by Grant and Lease Stipulation 1.21. The damage to the backpressure system has been repaired and is now in operation. Without the backpressure system in operation and with oil flow rate below 1.4 million/barrel day, vibrations due to oil vapor bubble collapse are induced into the TAPS pipeline just below Thompson Pass. JPO directed Alyeska to report the effect of the vibrations on pipeline integrity. The report's calculations show that the worst location, if the backpressure system remained offline, that in 1.5 years the pipe would reach an indeterminate condition for continued operations. There would be a 2% chance of the initiation of a crack in the pipe. The length of time to propagate this crack through the pipe wall is unknown. If the backpressure system is kept online and with 12 shutdowns/year it would take 24 years to reach a cumulative design fatigue damage of 100%.³⁹

Details: On January 30, 2000, the backpressure system at the Valdez Marine Terminal was damaged primarily as the result of failing to follow and use procedures during the capture of a scraper pig.⁴⁰ JPO directed Alyeska to provide: 1) a plan and schedule for the repair of the backpressure system; 2) a briefing on the causal factor analysis of the damage to the backpressure system; 3) an estimate of how long the backpressure system could remain off line without a danger to the integrity of the pipeline.⁴¹

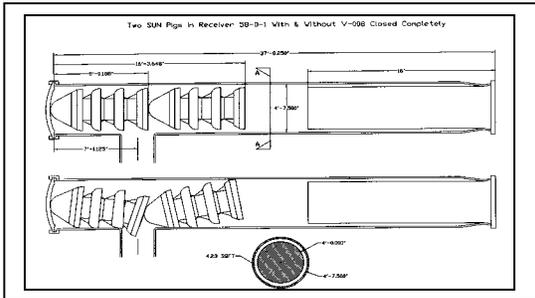
Figure 11: Effect of Two Pigs in Pig Trap (modified from Alyeska RCA)

Alyeska brought the backpressure system back on line February 21, 2000.⁴² JPO personnel participated in the causal factor analysis which was completed on April 5, 2000.⁴³ The incident was caused by closing valve V-008 more than 75% forcing the cleaning pig into the backpressure system. Alyeska completed its incident investigation and found a number of contributing causes including not following QA36-1, PIP 3.6 Change Management & PIP 5.2 Controlled Work Site and Department Procedures, and not developing Temporary Operating Procedures for washing pigs (*the pig is left in the pig traps with oil flowing over it to wash away the accumulated wax, oil and other grit*) with two pigs in the receiver.⁴⁴ Alyeska noted that two incidents similar to this one occurred in the past at PS-10. JPO’s analysis of the event concur

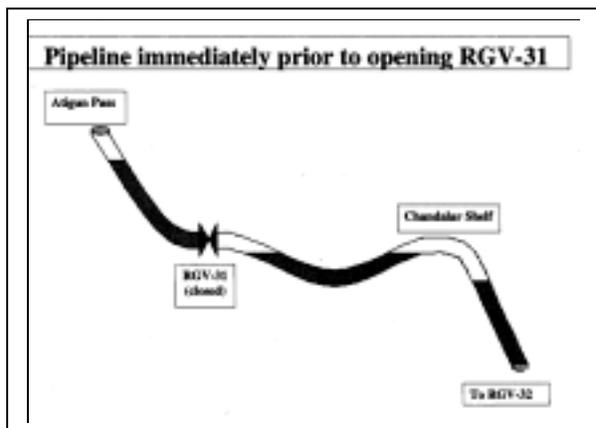
Figure 16: Oil Position Prior to RGV 31 Opening (modified from Alyeska RCA)

The Alyeska root cause analysis (Alyeska RCA) found that a pressure pulse was caused by the collapse of a vapor pocket just south of RGV-31 when RGV-31 was reopened after a pipeline shutdown on April 17, 2000.⁵¹ This pressure pulse caused the damage to the pipeline supports. Figure 16 (above) shows the position of the oil in the pipeline prior to the opening of RGV-31. Once RGV-31 was fully open, the oil column above RGV-31 traveled and collided with the column down stream shown in Figure 17. The impact caused a pressure pulse to move downstream and upstream. Most of the upstream section of pipe is aboveground. The above ground pipe is designed to move in a controlled manner and absorb energy using various sacrificial elements such as aluminum honeycomb absorbers at the pipeline anchors. The below ground pipe is restrained by the surrounding soil and does not experience lateral or transverse movement.

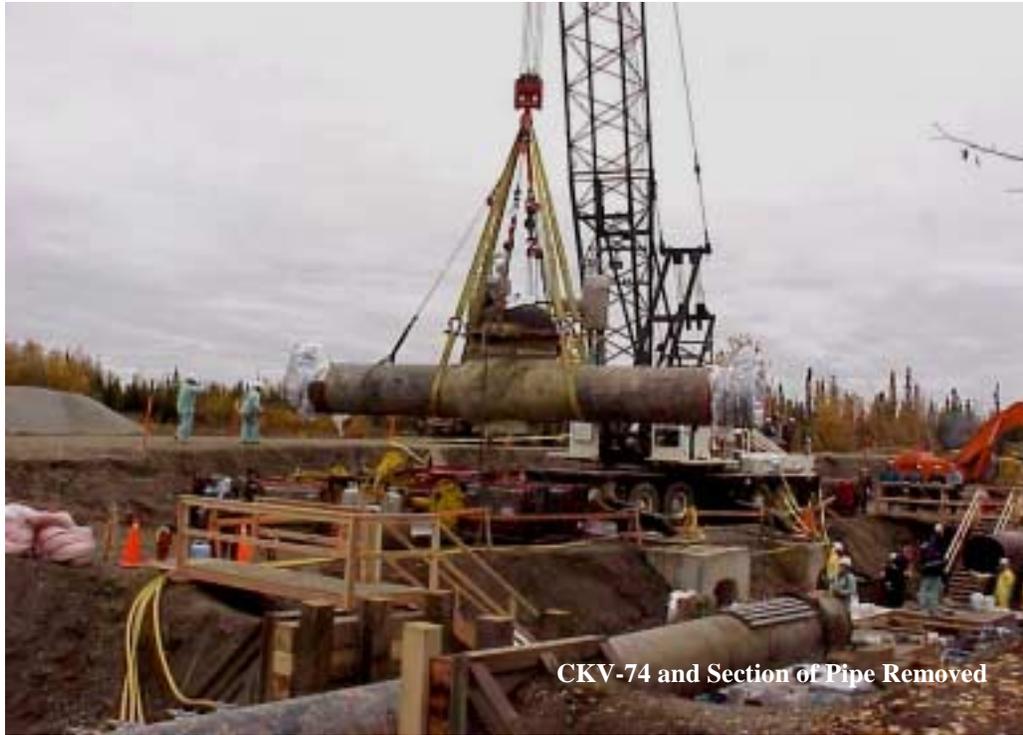
CKV-74 and Section of Pipe Removed

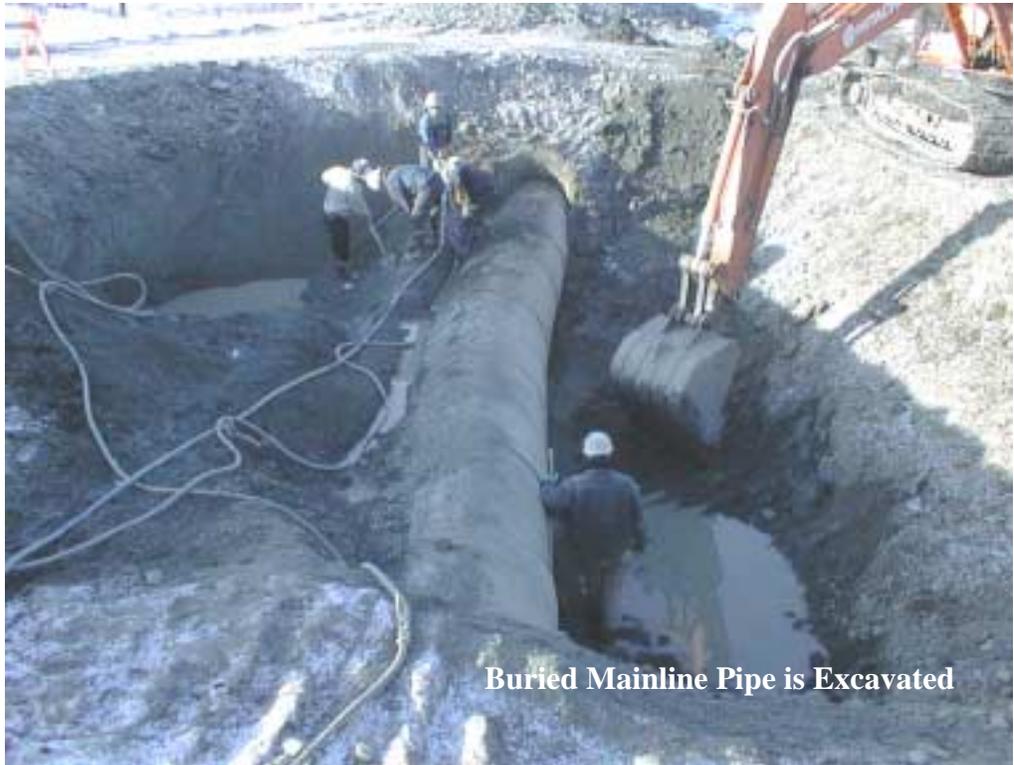
Buried Mainline Pipe is Excavated

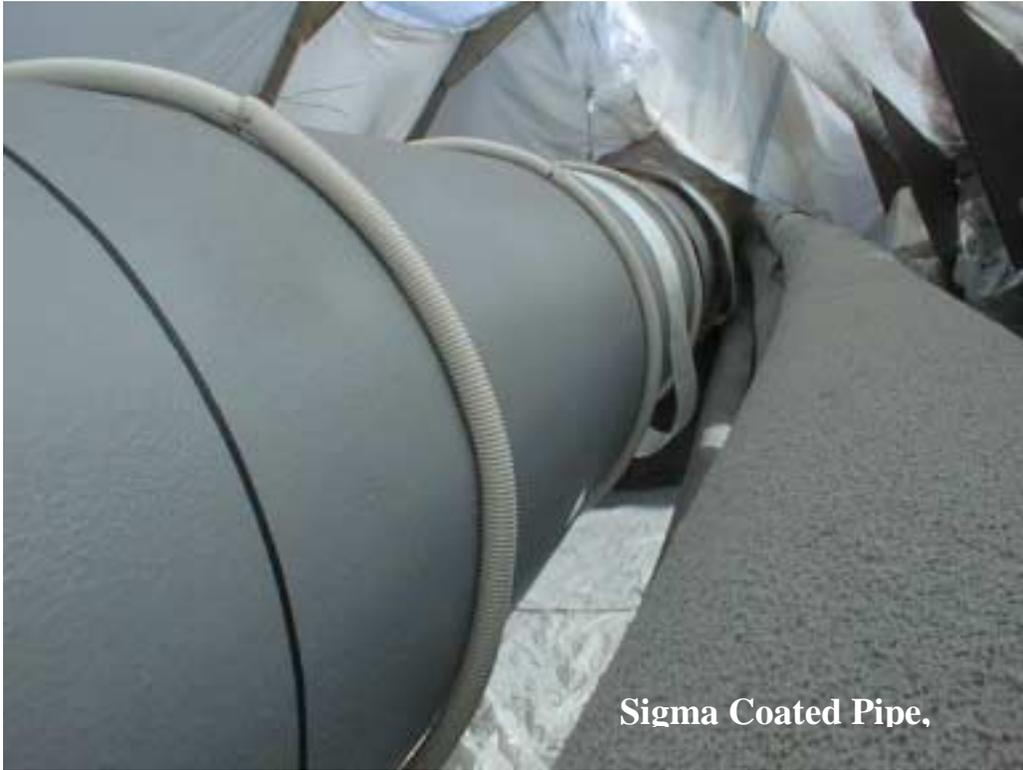
Sigma Coated Pipe,
