## **Comprehensive Monitoring Program Report**

### **A Look at Alyeska Pipeline Service Company's Operation of the Trans-Alaska Pipeline System 1999/2000**

February 2001

# **Joint Pipeline Office**

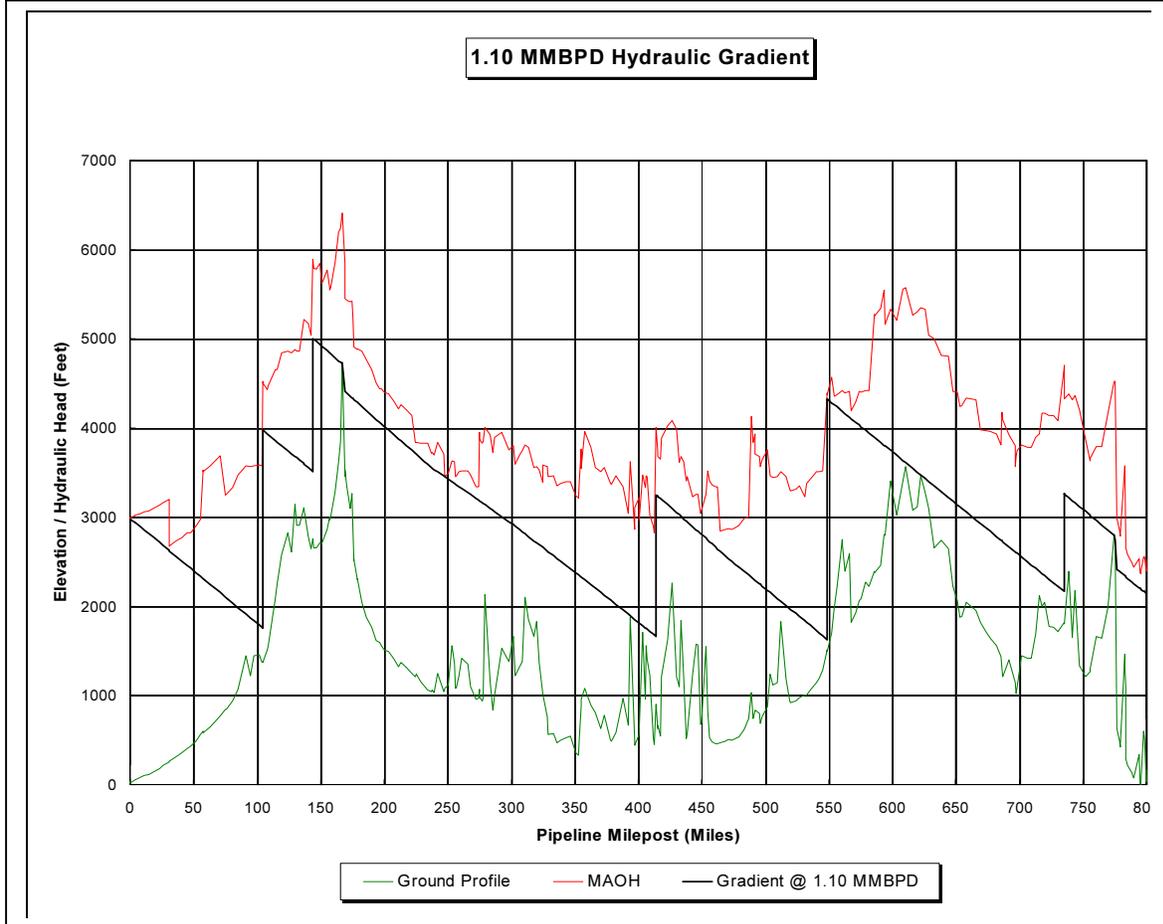
**Figure 1 Hydraulic Gradient - Pipeline Head Pressure Must be Maintained Below the Maximum Allowable Operating Head (MAOH) Line**

hydraulic significance (pinch points), corrosion derates and pig calls. The investigation found that at one location, milepost 247, the MAOP was exceeded by a slight margin (less than .5%) on several occasions during three of the four days sampled.

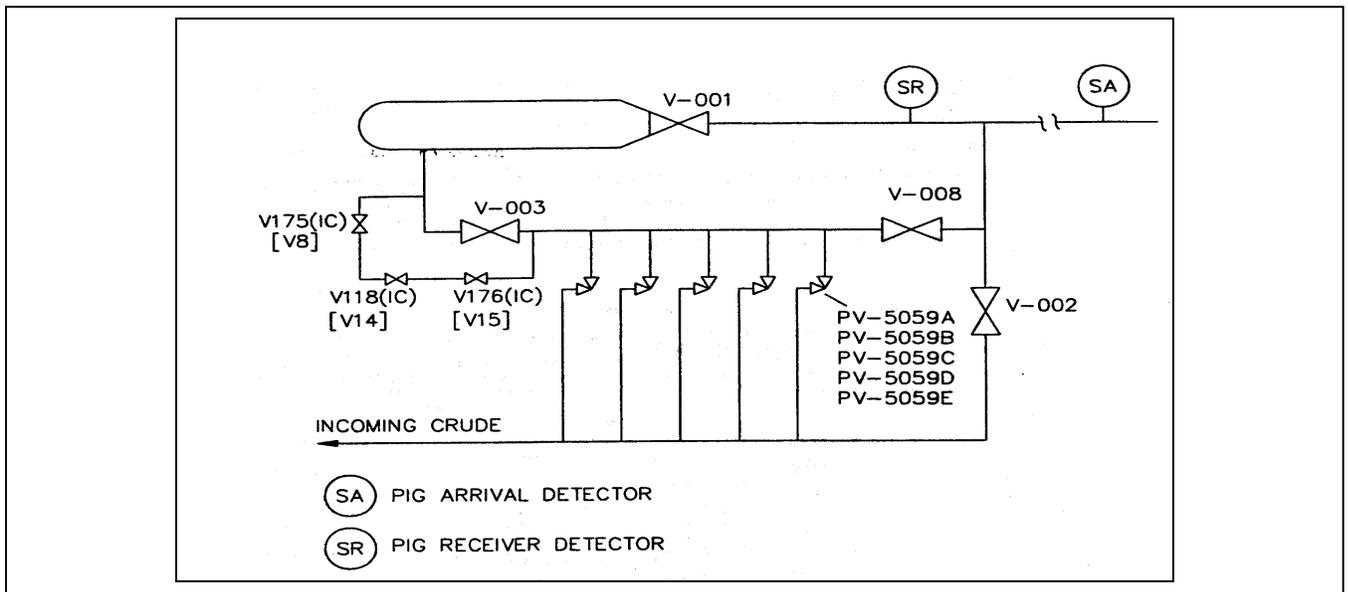
**Figure 10: Piping & Valves Connection Pig Trap and Backpressure System**

**2000 Status:** On January 30, 2000, the backpressure system at the Valdez Marine Terminal was damaged primarily as the result of failing to follow and use procedures for the capture of a scraper pig in the pig trap. In addition, the management of change process was not followed to prepare a procedure for receipt of two pigs in the pig trap. The failure to follow procedure and poor change management represents an incident where safe and workmanlike pipeline operations were not followed as required by Grant and Lease Stipulation 1.21. The damage to the backpressure system has been repaired and is now in operation. Without the backpressure system in operation and with oil flow rate below 1.4 million/barrel day, vibrations due to oil vapor bubble collapse are induced into the TAPS pipeline just below Thompson Pass. JPO directed Alyeska to report the effect of the vibrations on pipeline integrity. The report's calculations show that the worst location, if the backpressure system remained offline, that in 1.5 years the pipe would reach an indeterminate condition for continued operations. There would be a 2% chance of the initiation of a crack in the pipe. The length of time to propagate this crack through the pipe wall is unknown. If the backpressure system is kept online and with 12 shutdowns/year it would take 24 years to reach a cumulative design fatigue damage of 100%.<sup>39</sup>

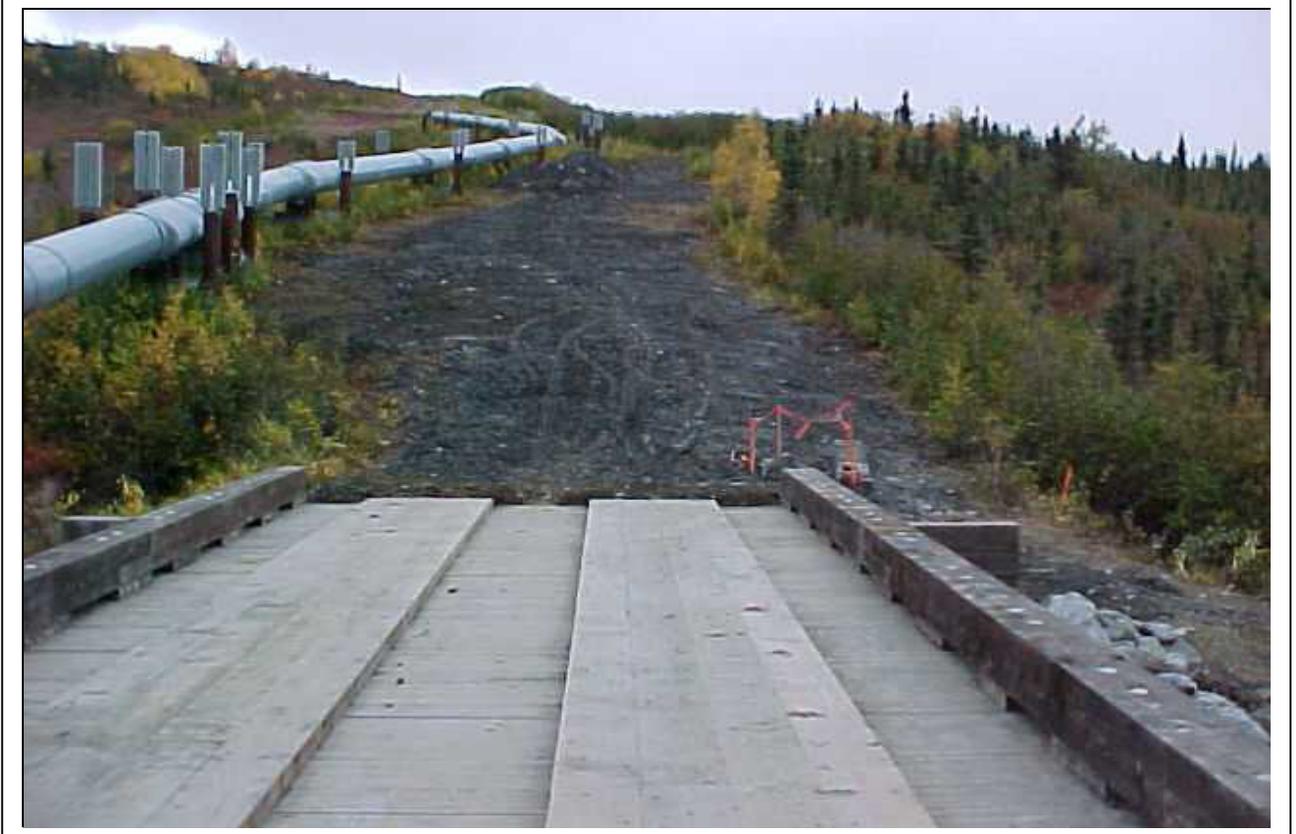
**Figure 19: Pungs Crossing Workpad Bridge**

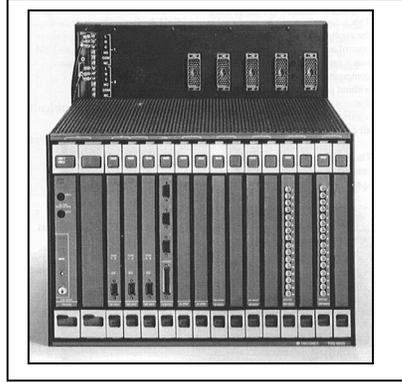
**Status:** By the end of 1999, Alyeska had completed all actions required by the plan except replacing the old Systronic master terminal units at the pump stations with triple modular redundant control units. This project is also discussed in the Construction CMP.

**Figure 20: Triconlite Remote Terminal Unit**
